STRUCTURAL ASSESSMENT REPORT

WASHINGTON PARK NATIONAL BANK

6300 South Cottage Grove Ave. Chicago, Illinois 60637

RE: Structural Assessment Report for Washington Park National Bank Building 6300 S. Cottage Grove Chicago, Illinois, 60637 Probe Project No: 2018.529

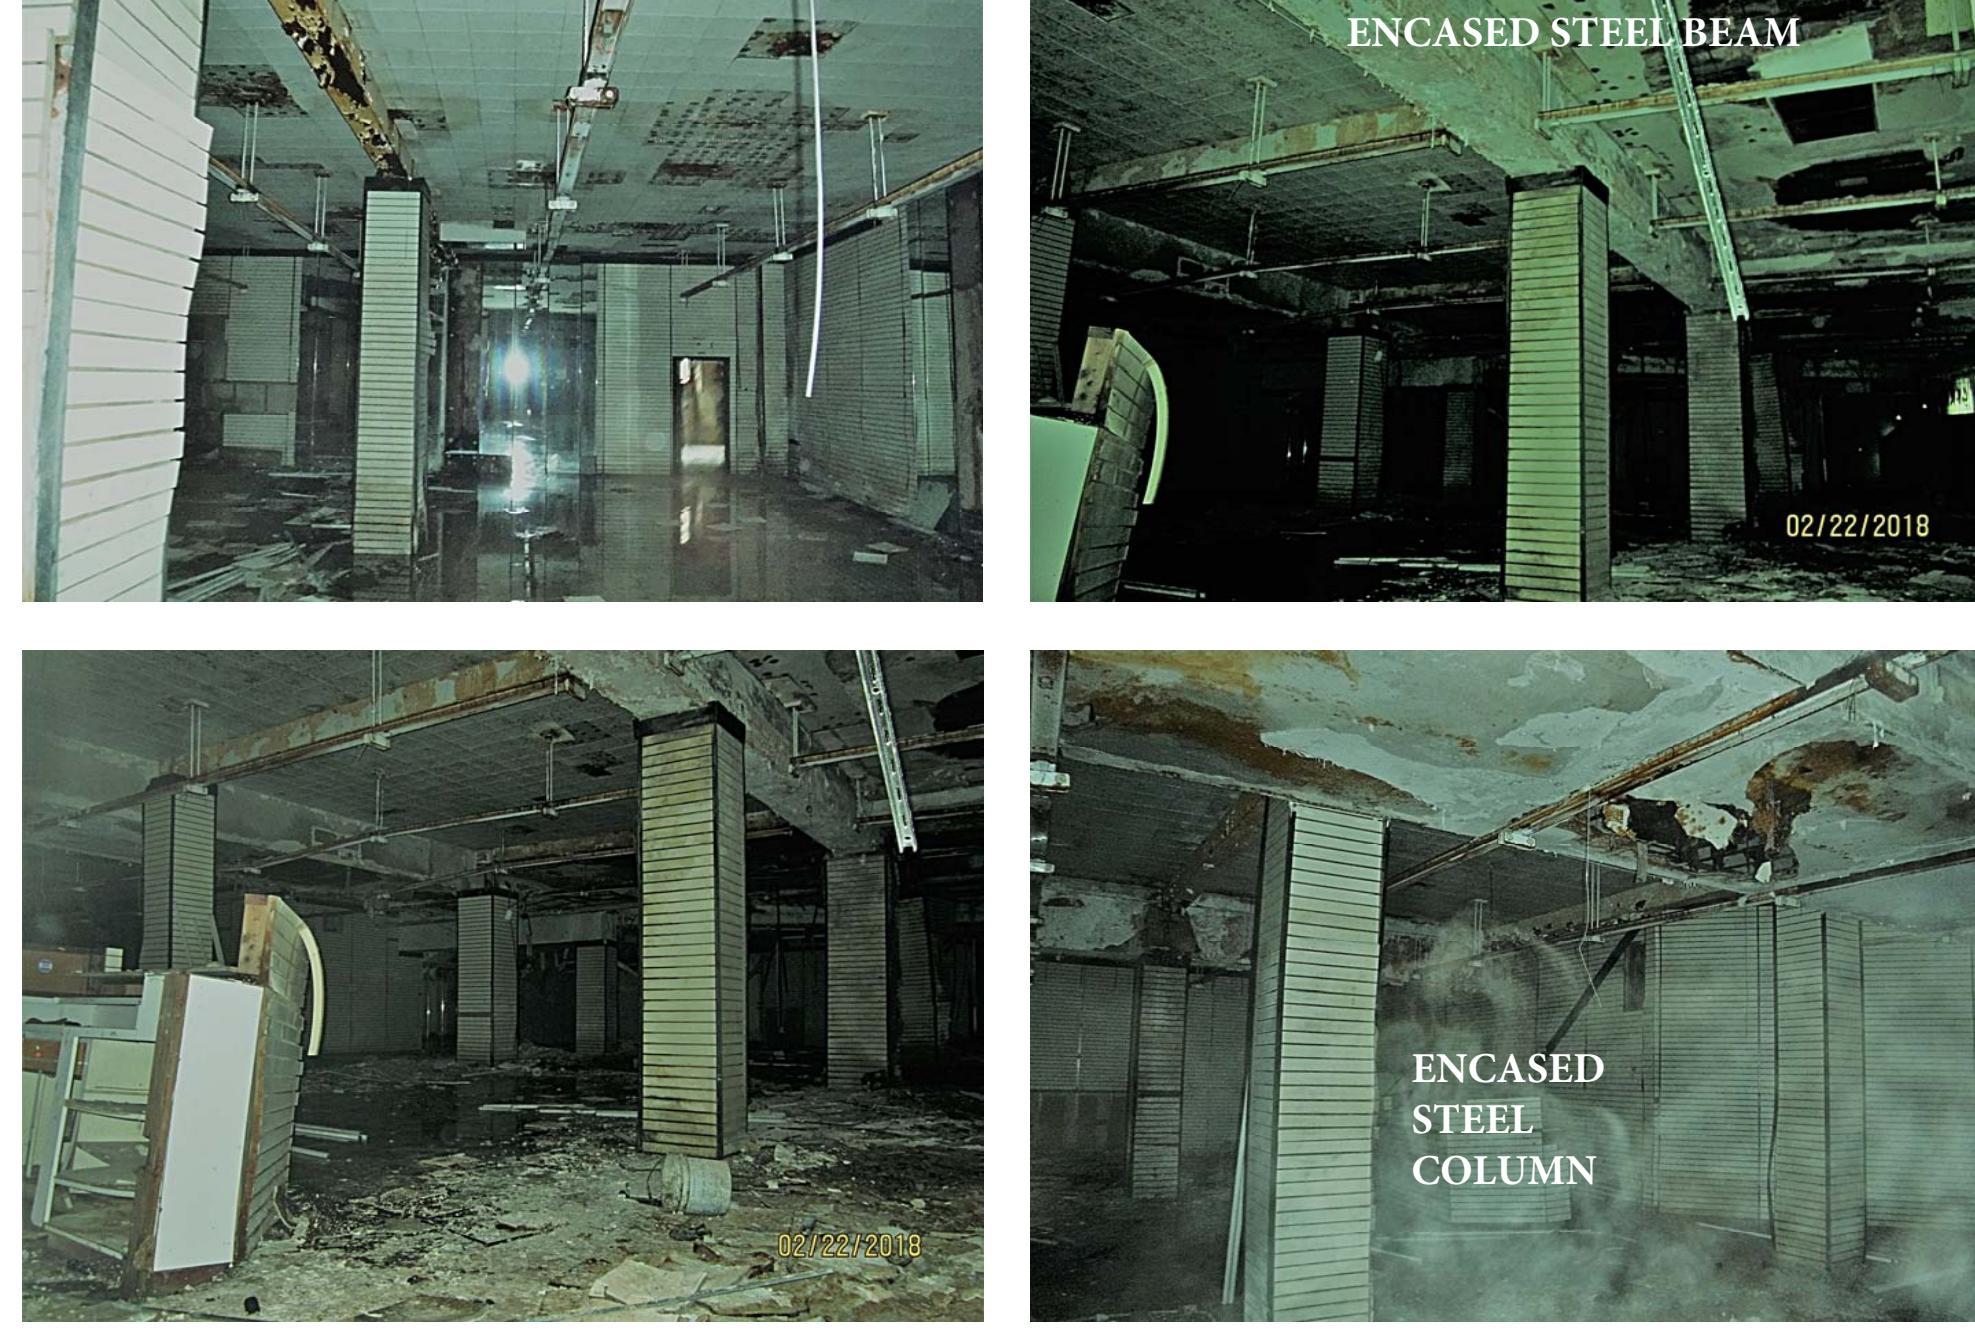
Page 2

FIRST FLOOR VIEW : NOTE COLUMNS AND BEAMSSUPPORTING 2nd FLOOR

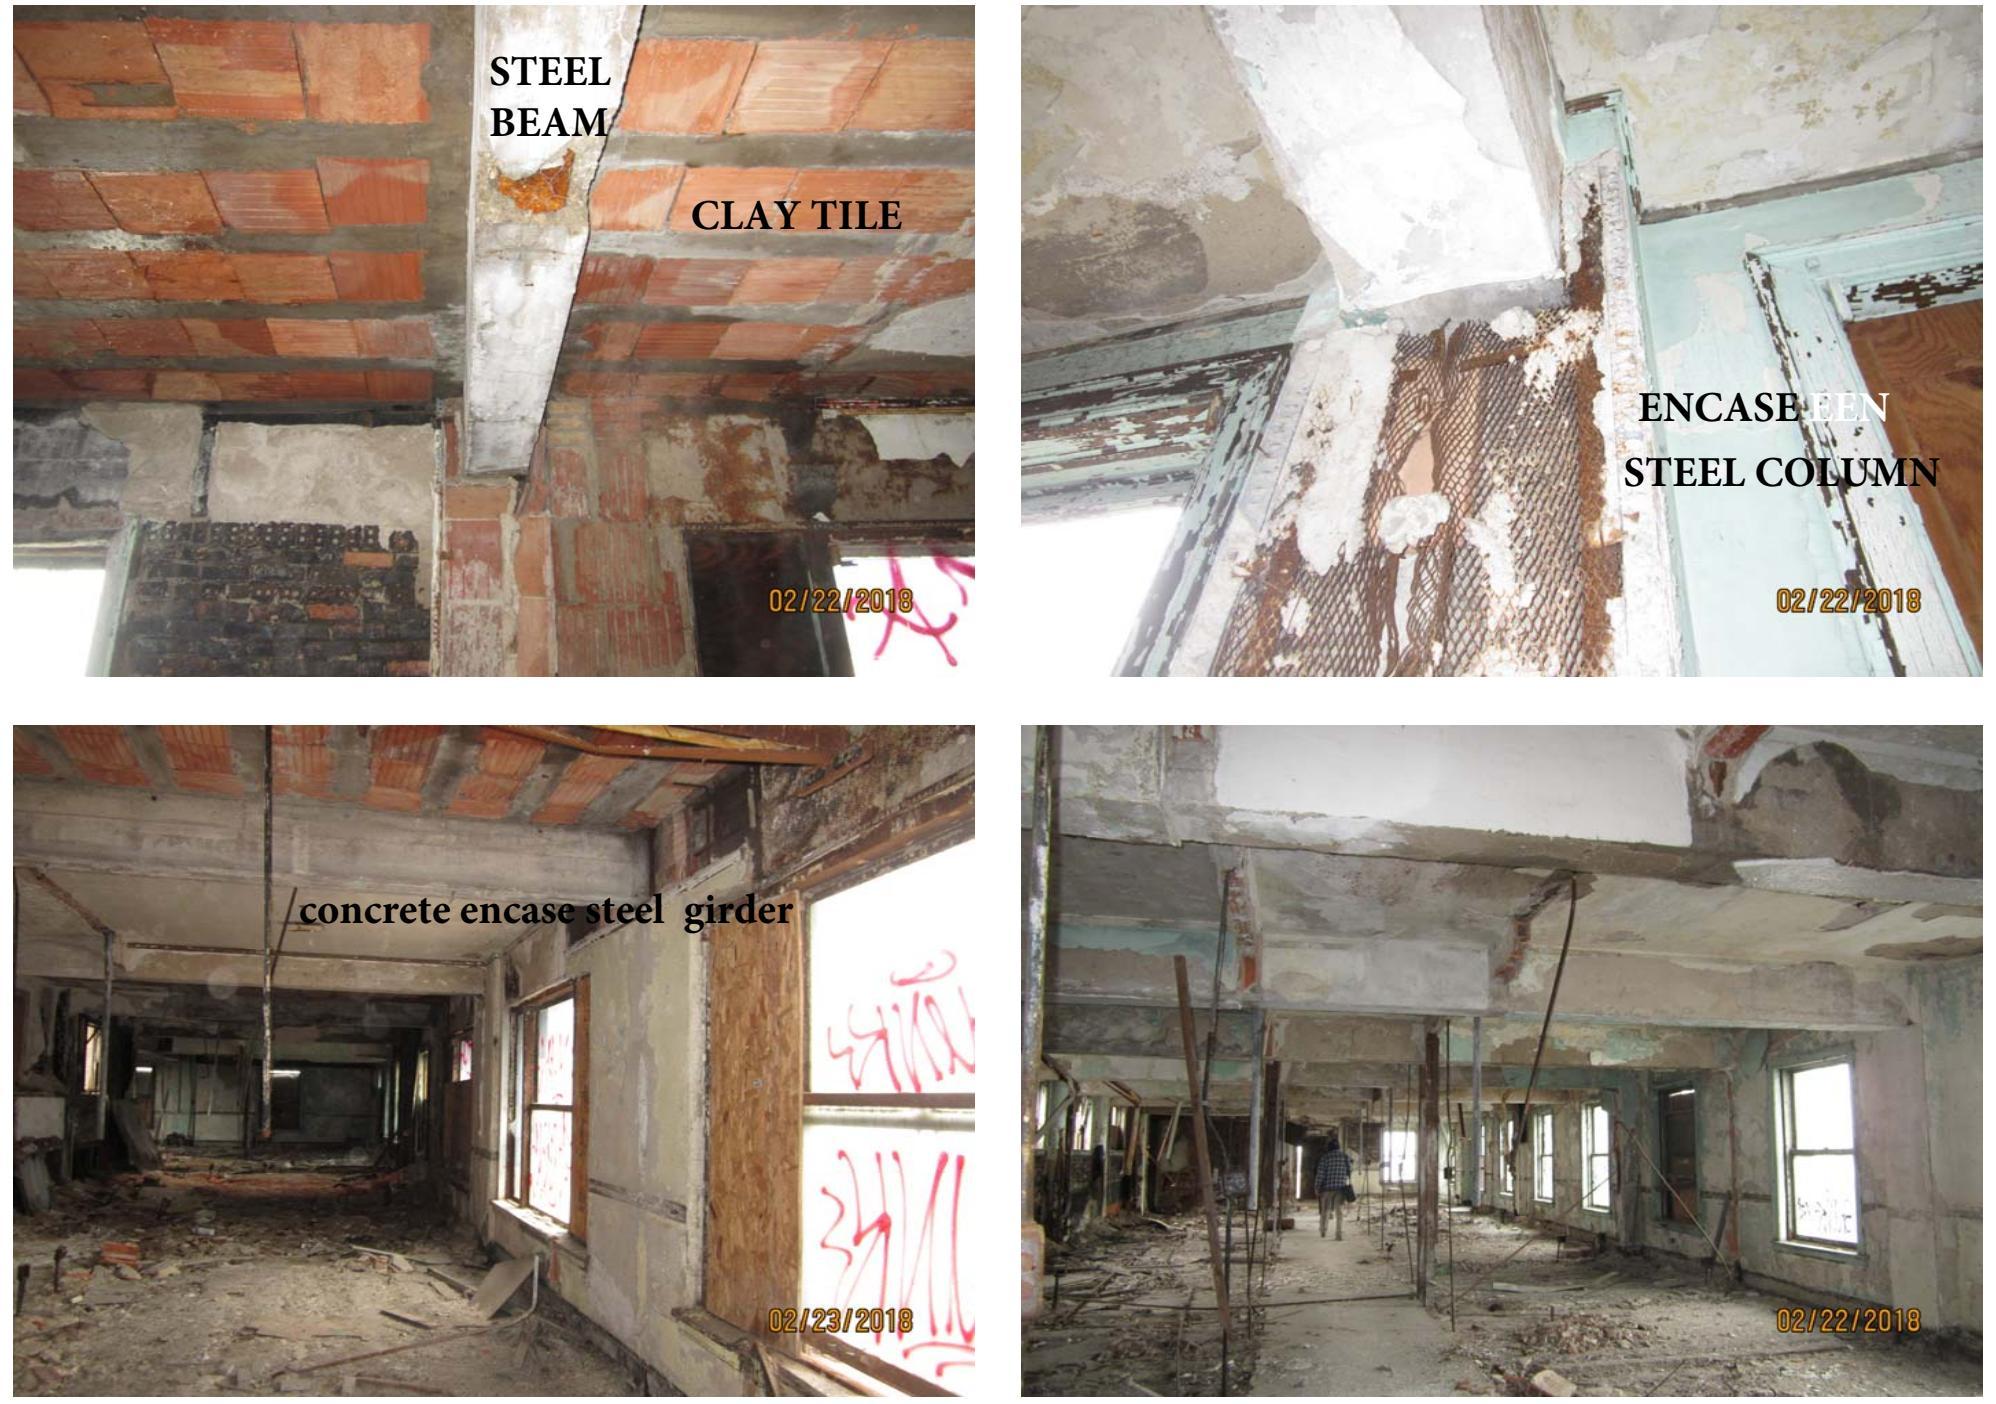
TYPICAL STRUCTURAL COMPOSITE CONCRETE CLAY-TILE FLOOR, Note concrete encased steel beams and columns . Underside of floors in good condition. View at the underside of 3r, 4th floors and roof. Page 3

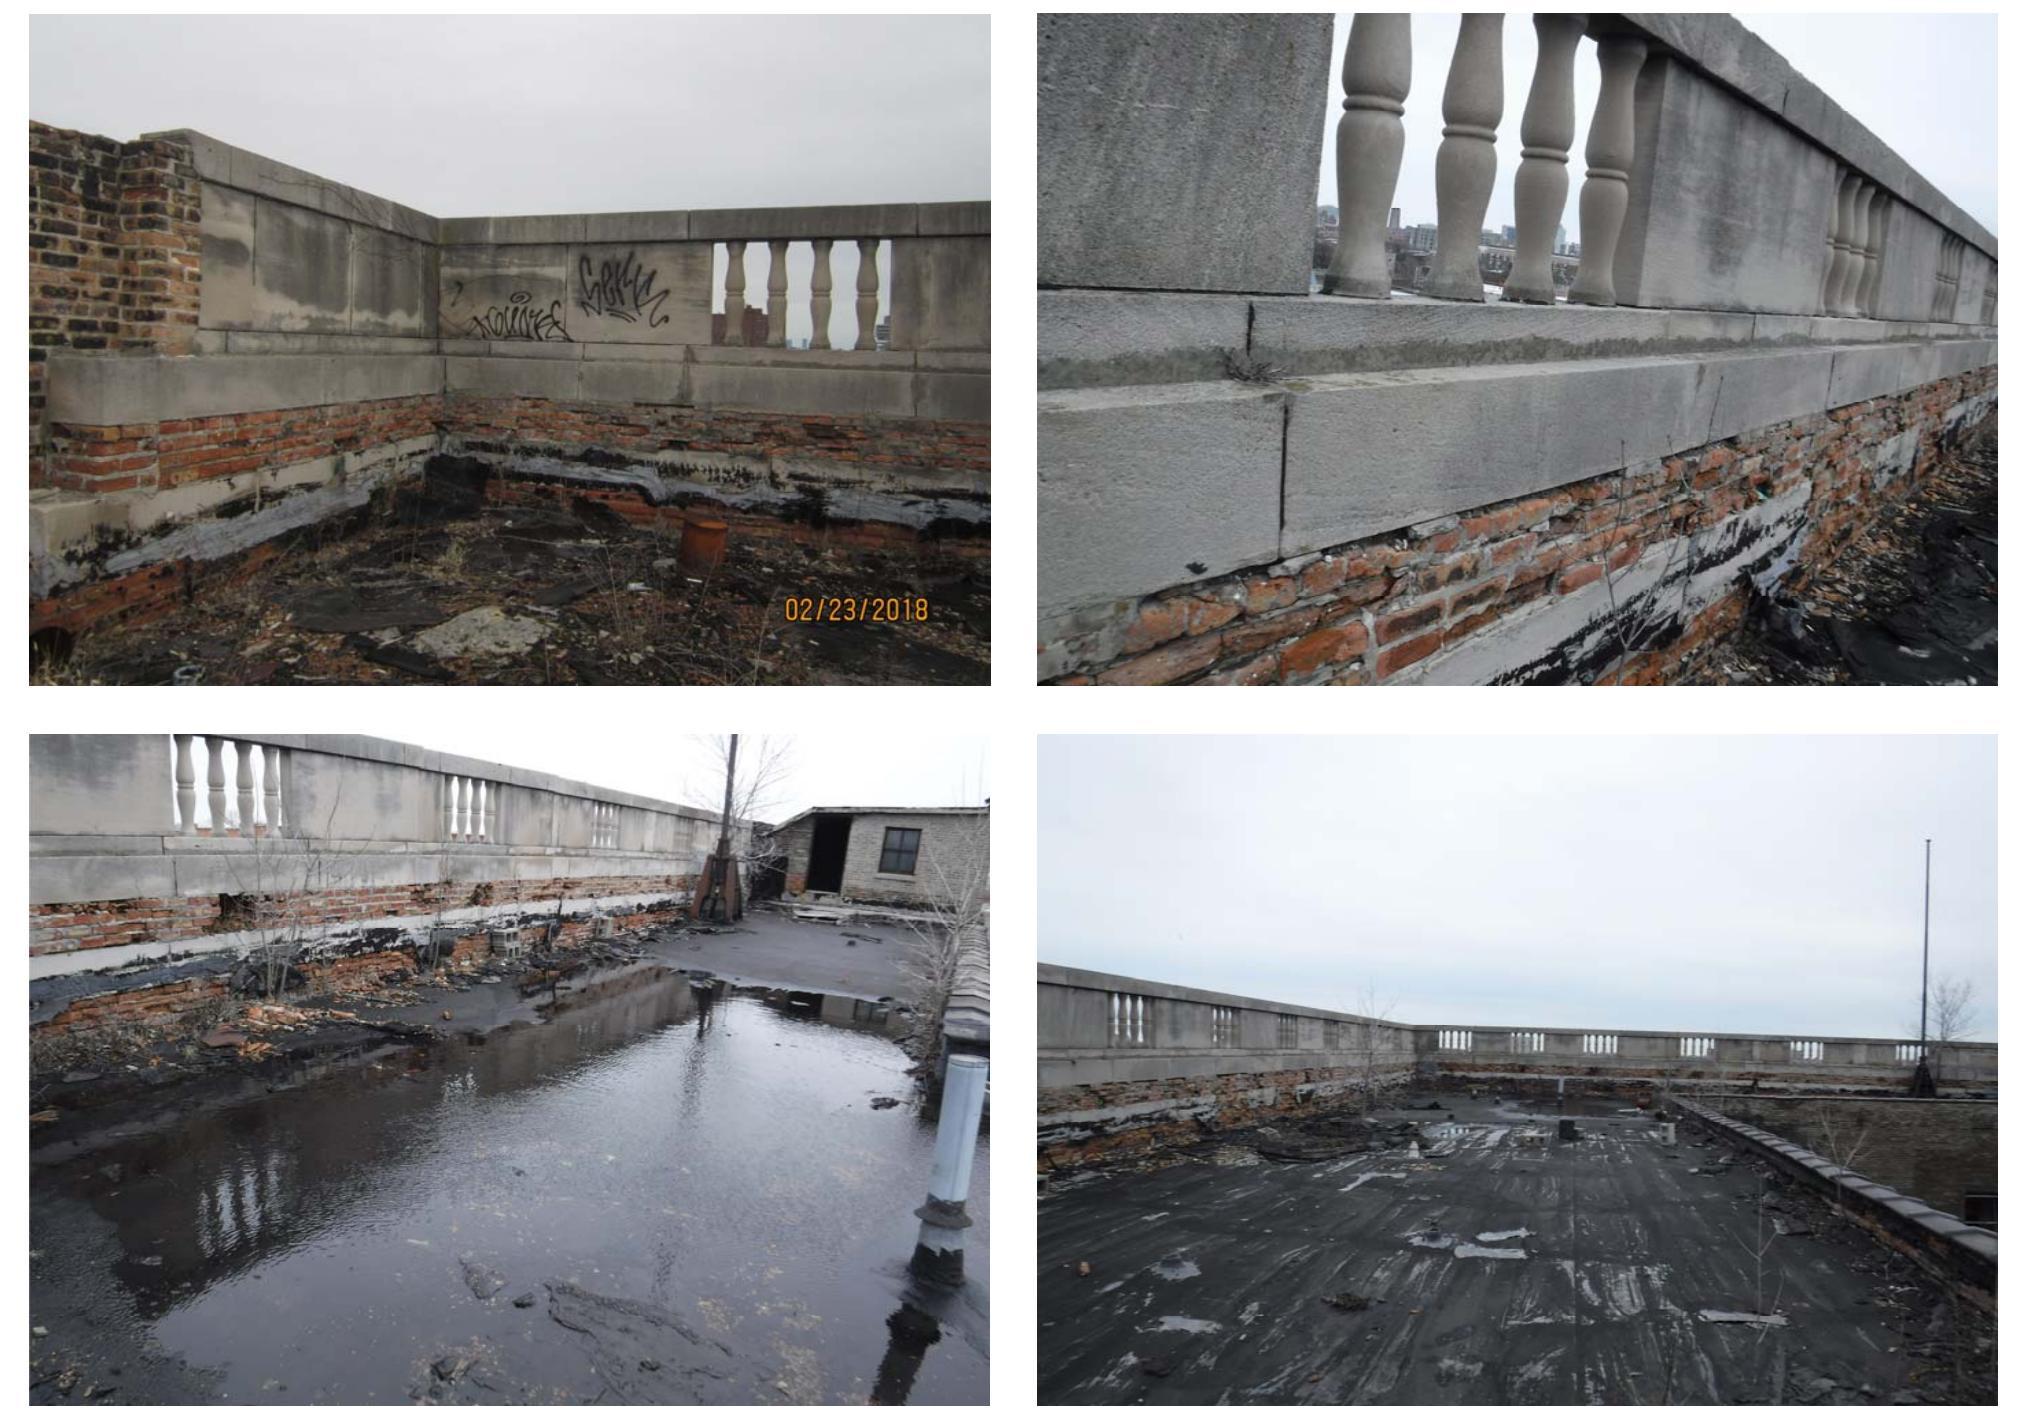
The building roof was in a poor condition with water puddles especially in the northern portion of the building. Vegetation and plant growth were observed along the edge of parapets,

The tall roof top parapets are composed of brickwork supporting the limestone cornice and balusters and balustrades. The parapets exhibited moderate damage in the form of open mortar joints, loose brickwork, and plant growth. The limestone elements showed some displacements and open and deteriorated joints.

ROOF TOP V: Note ponding and deteriorated brickwork and limestone parapets.

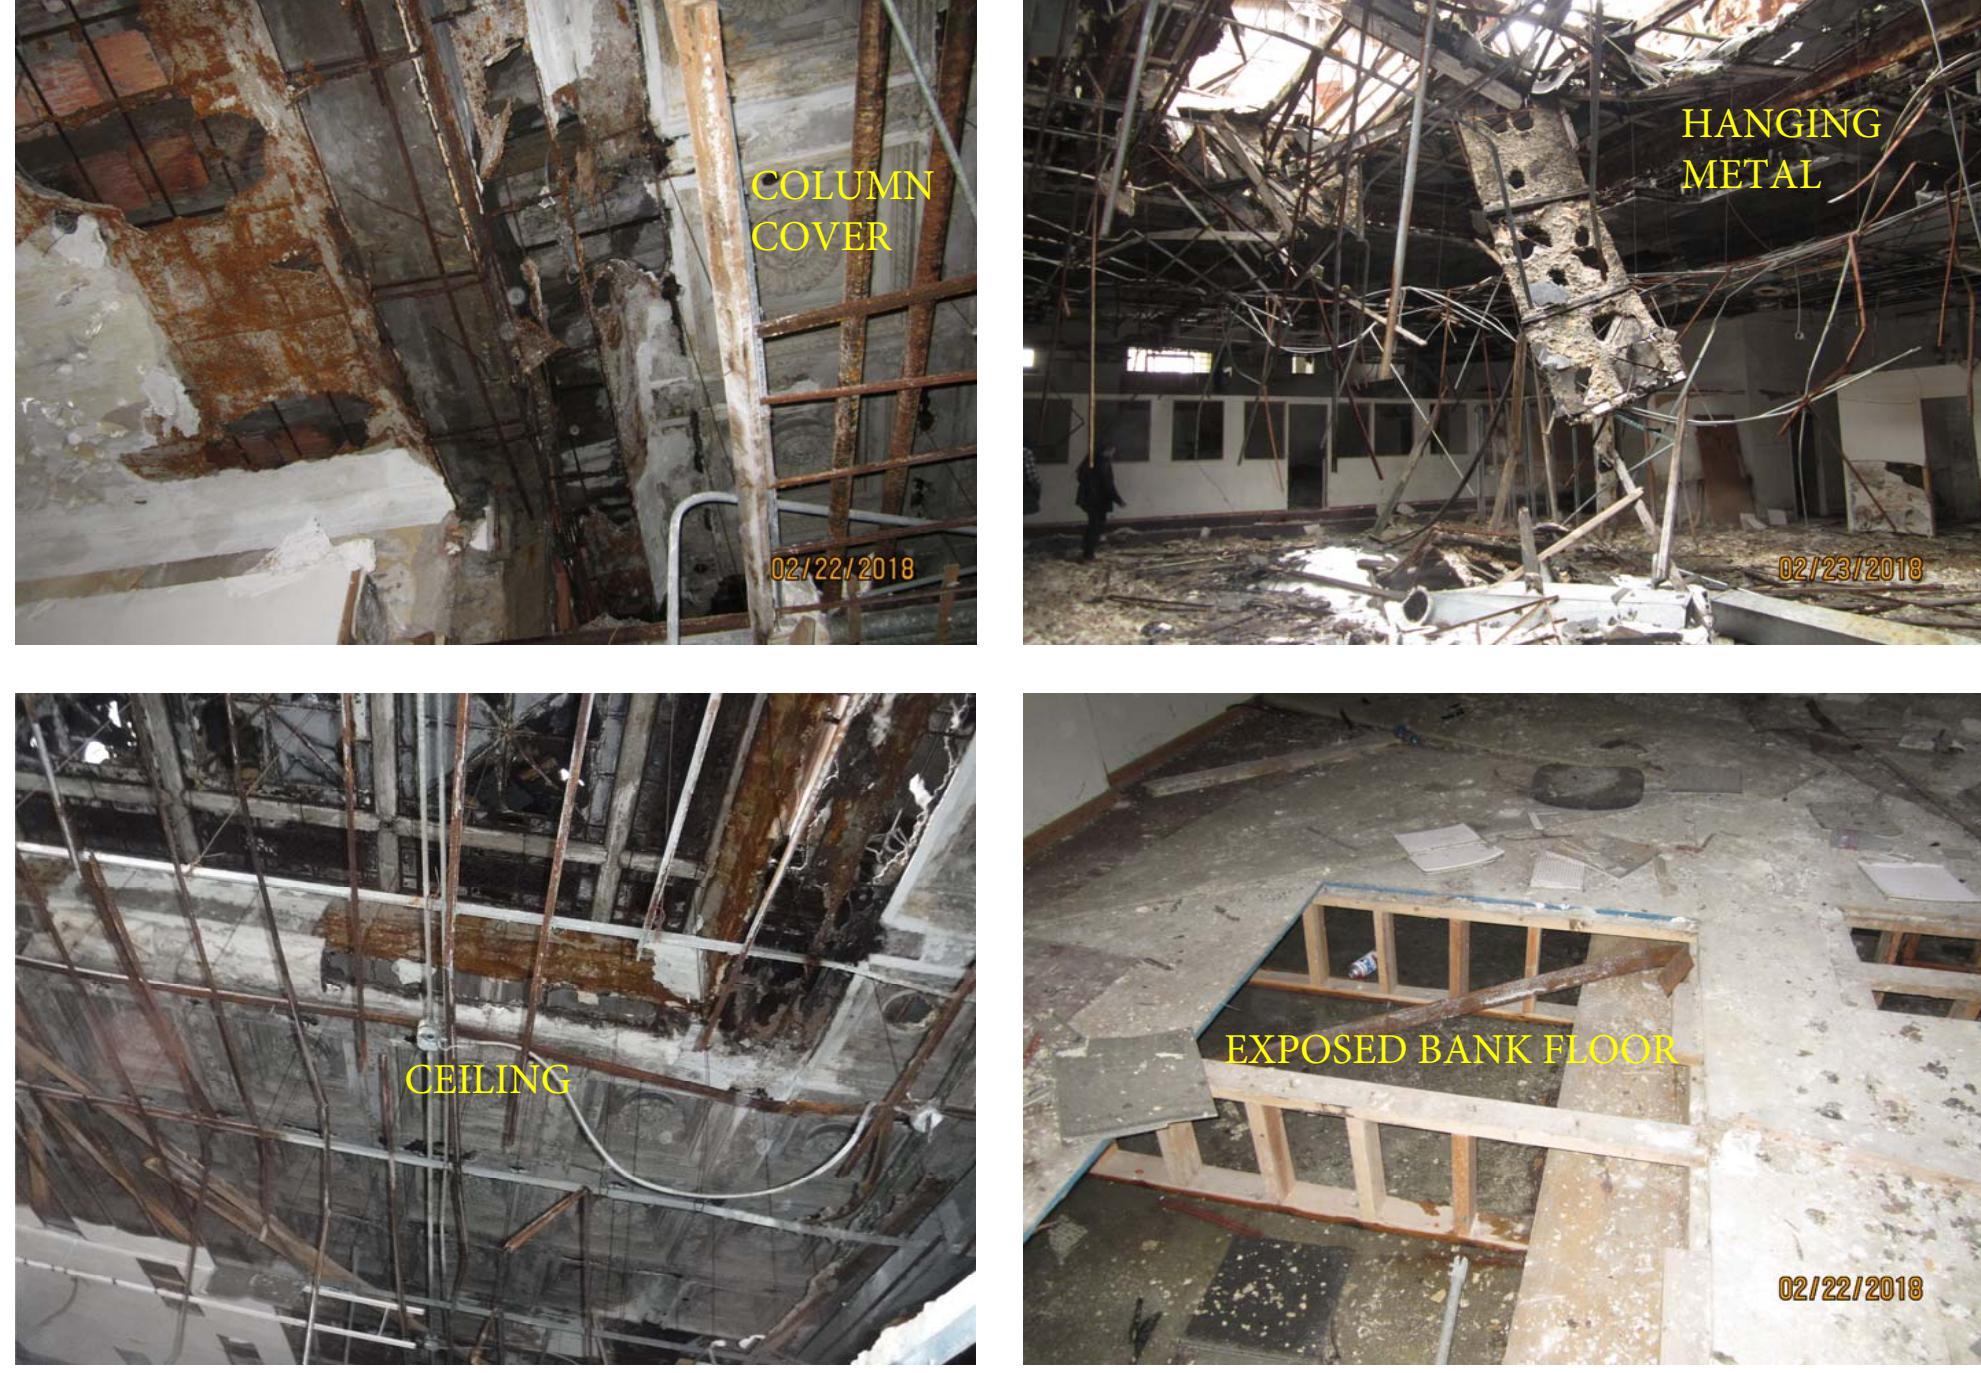
VIEWS OF THE MAIN ATRIUM FLOOR (2nd Floor), Note loose ceiling tiels, framing, and finishings. Page 5

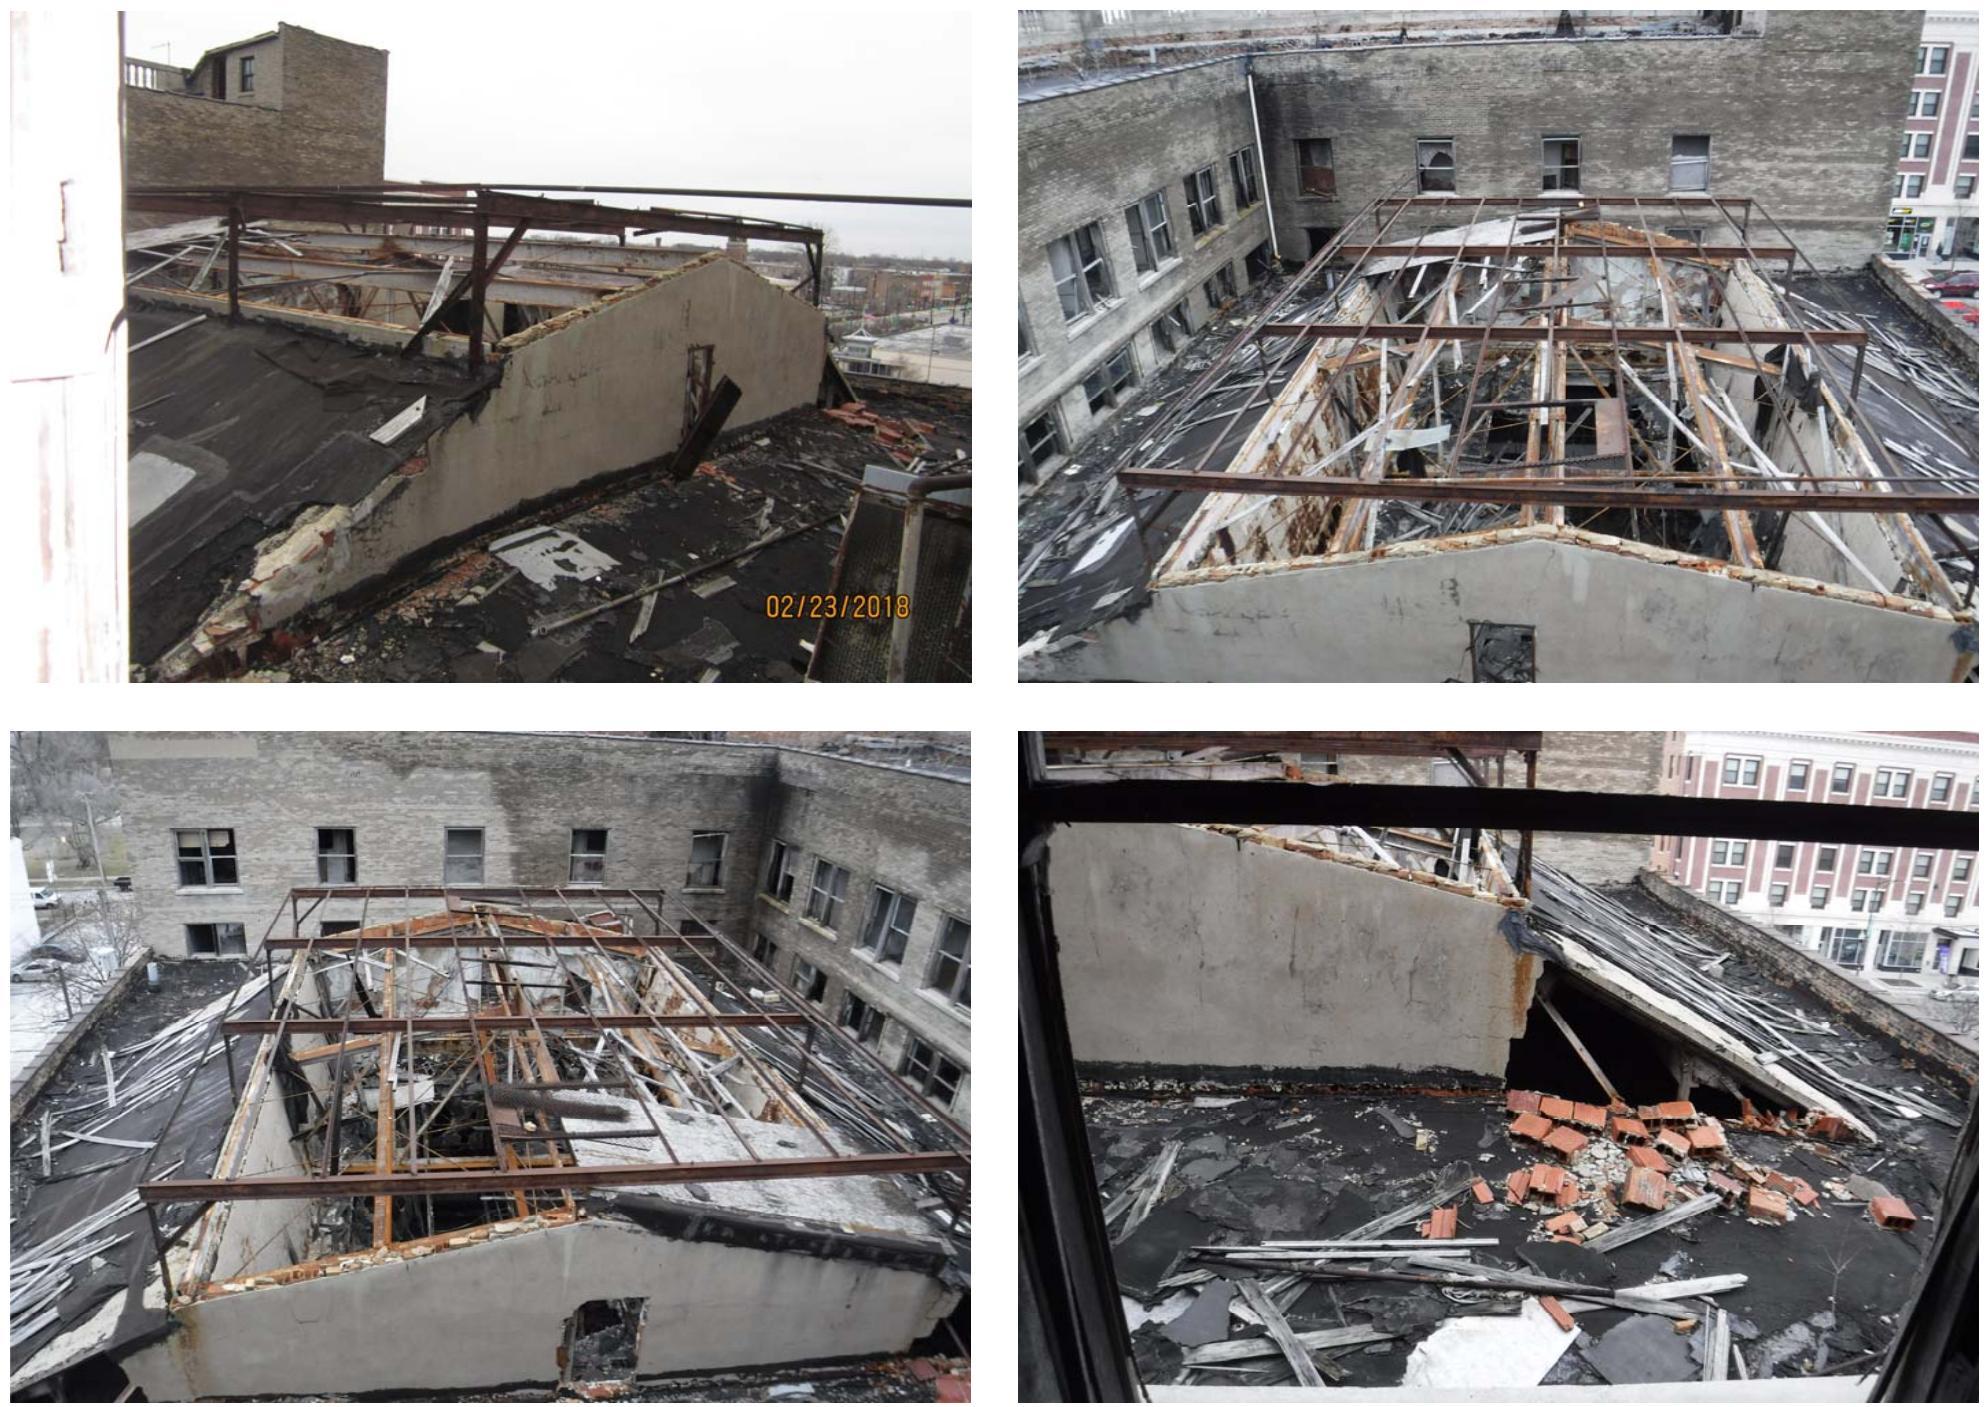
We did not see any visible signs of damage to the main structural framing system which is composed of beams, girders and columns. The under-side of the floors was found to be in good condition. Although, the atrium skylight framing roof had collapsed, it is considered secondary since it was supported by main structural framing of the building (mainly the 3rd floor). The main east and west concrete walls supporting the Atrium roof framing were still standing and intact.

ATRIUM CEILING FRAMING SUPPORTED BY 3rd FLOOR. Note loose secondary framing of atrium roof which not a part of main structural framing of the building. Main steel framing was not visible. Page 6

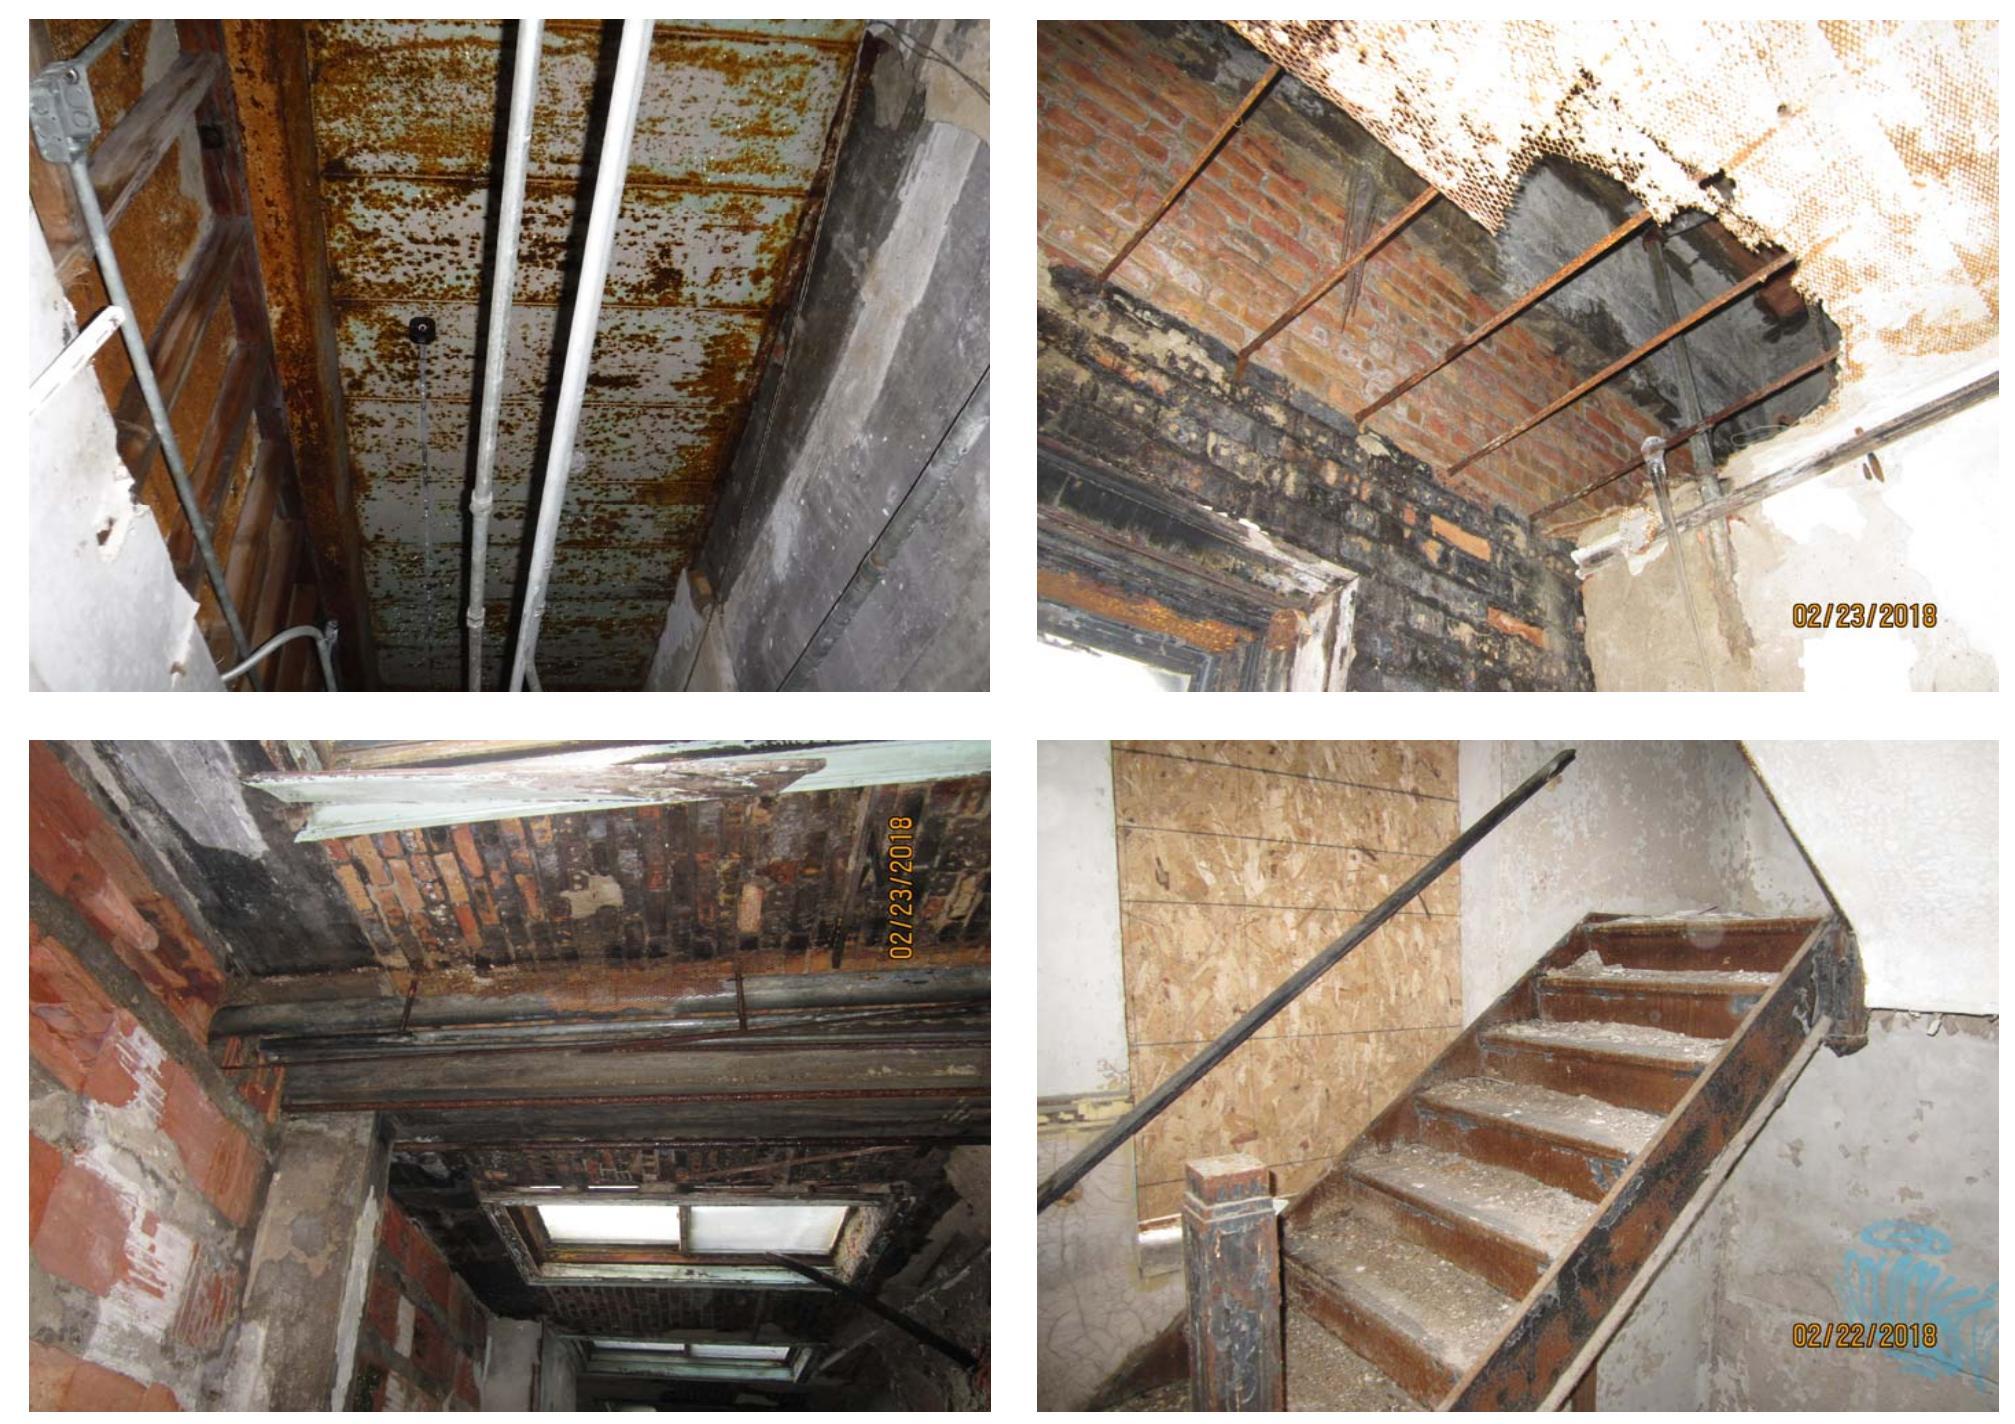
TYPICAL CONSTRUCTION DETAILS : Note interior facing of perimeter masonry walls, steel stairs, and
perimeter concrete encased steel columns found to be in sound condition.Page 7

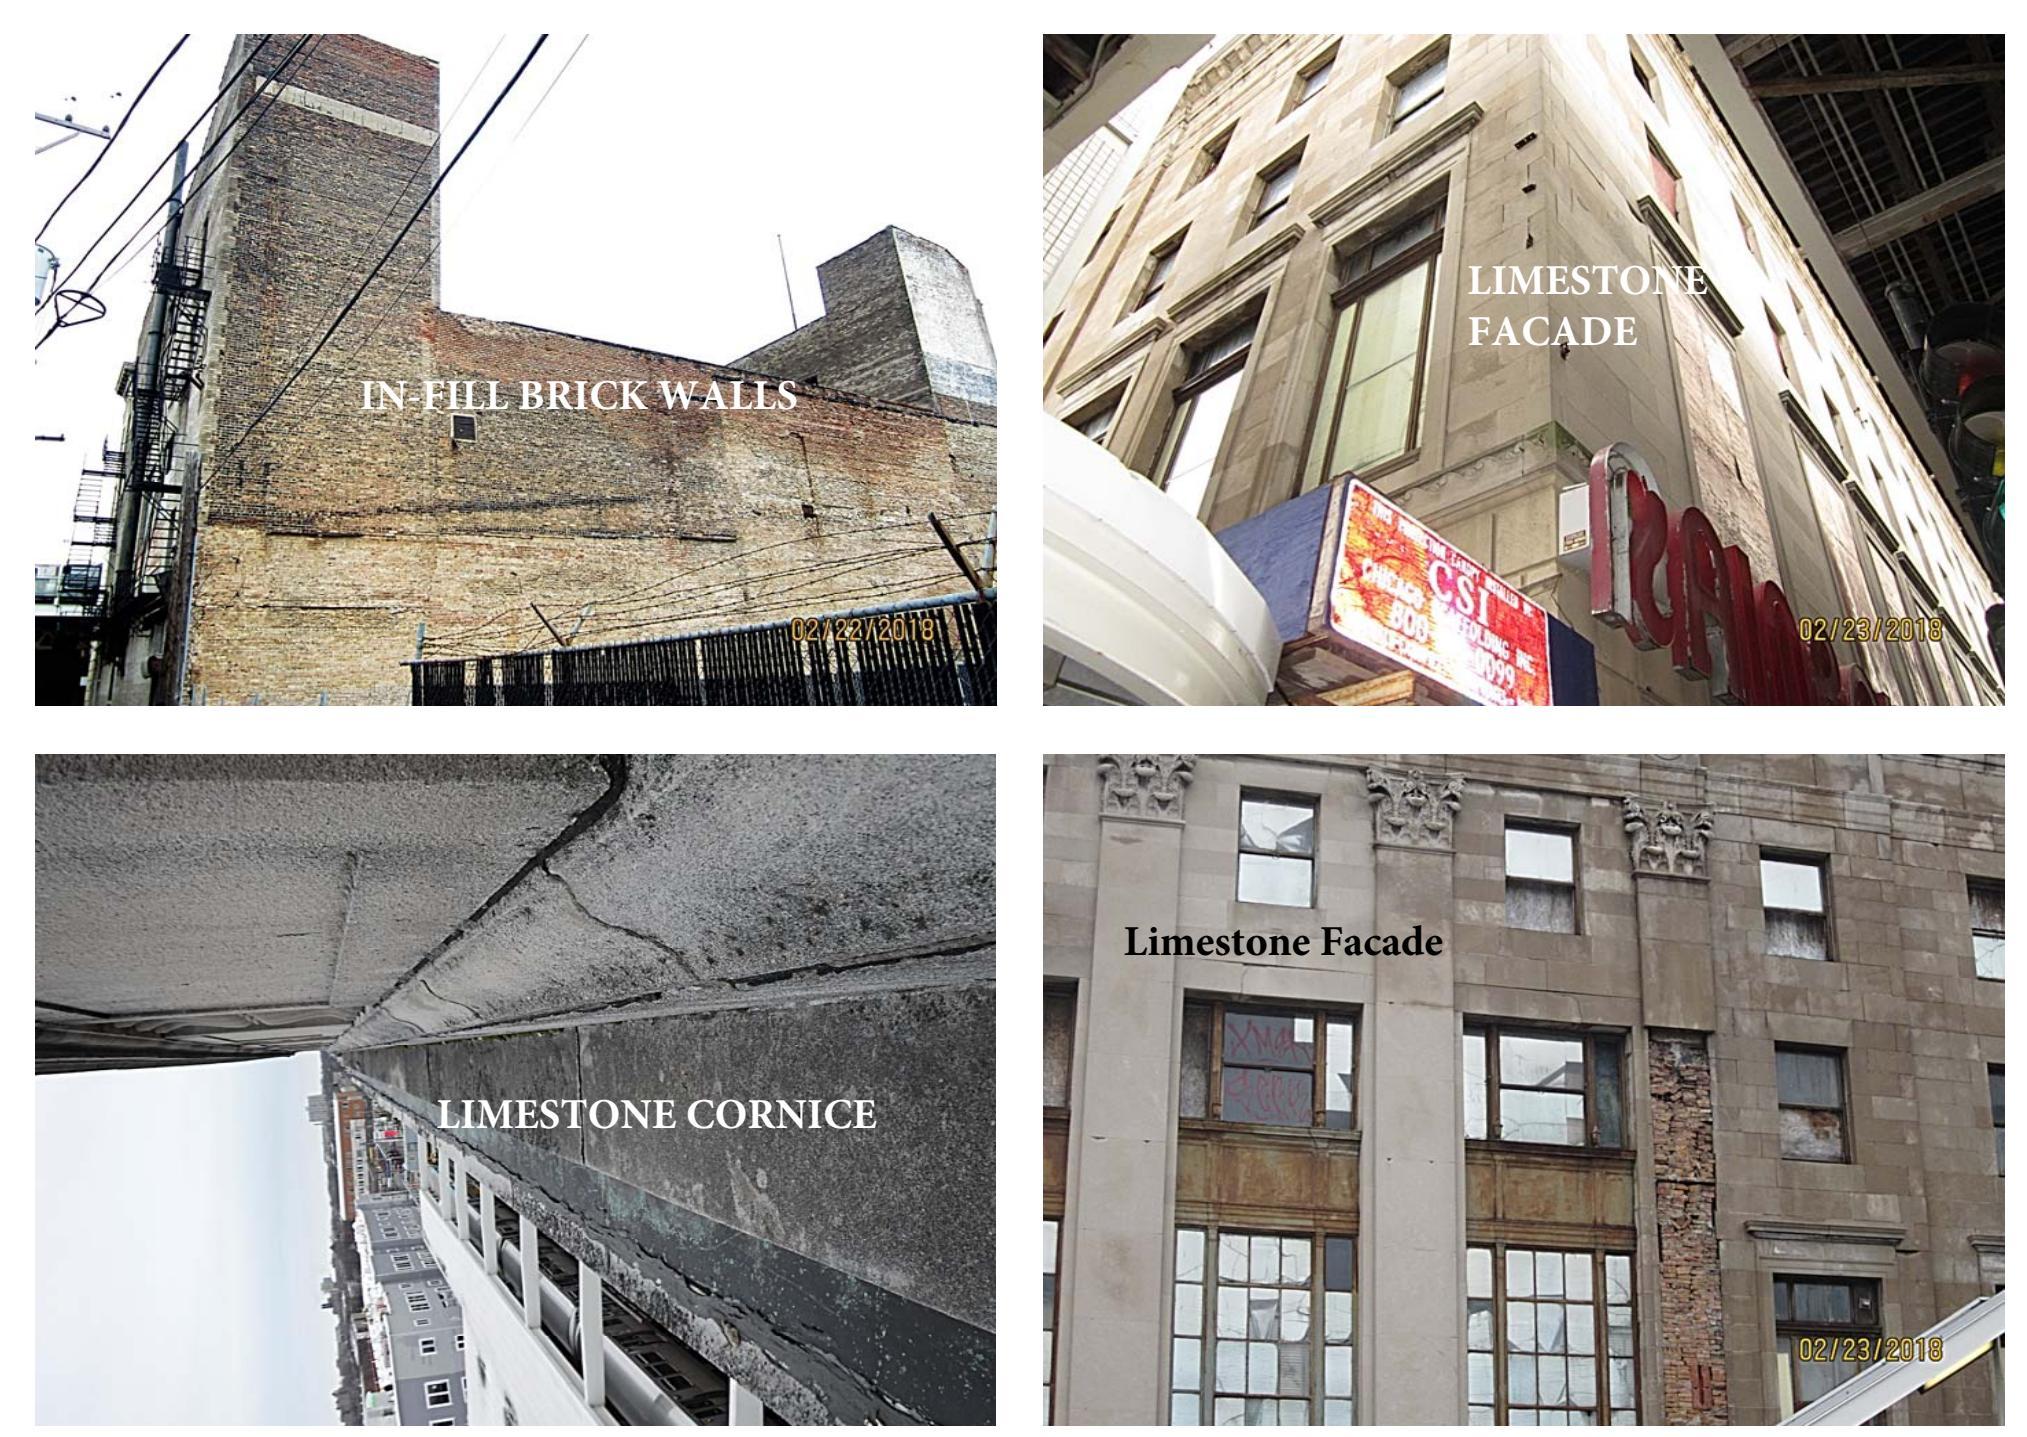
A.4 Facades and Exterior walls and Parapets: The building facades on the street fronts are composed of Bedford Limestone and were generally found to be in fair condition. A portion of limestone had previously fallen down on the Cottage Grove side. A street side canopy has been installed as a precautionary safety measure. The facades on west and south elevations include in-fill brick masonry walls supported by perimeter steel girders. The brick walls were found to be in fair condition with few signs of cracking and spalling.

EXTERIOR WALLS WERE GENERALLY IN FAIR CONDITION. Exceptions include fallen limestone pieces and open mortar joints which should be repaired. Brick walls on south and west were OK. Page 8
