STRUCTURAL ASSESSMENT REPORT

WASHINGTON PARK NATIONAL BANK

6300 South Cottage Grove Ave. Chicago, Illinois 60637

RE: Structural Assessment Report for Washington Park National Bank Building 6300 S. Cottage Grove Chicago, Illinois, 60637 Probe Project No: 2018.529

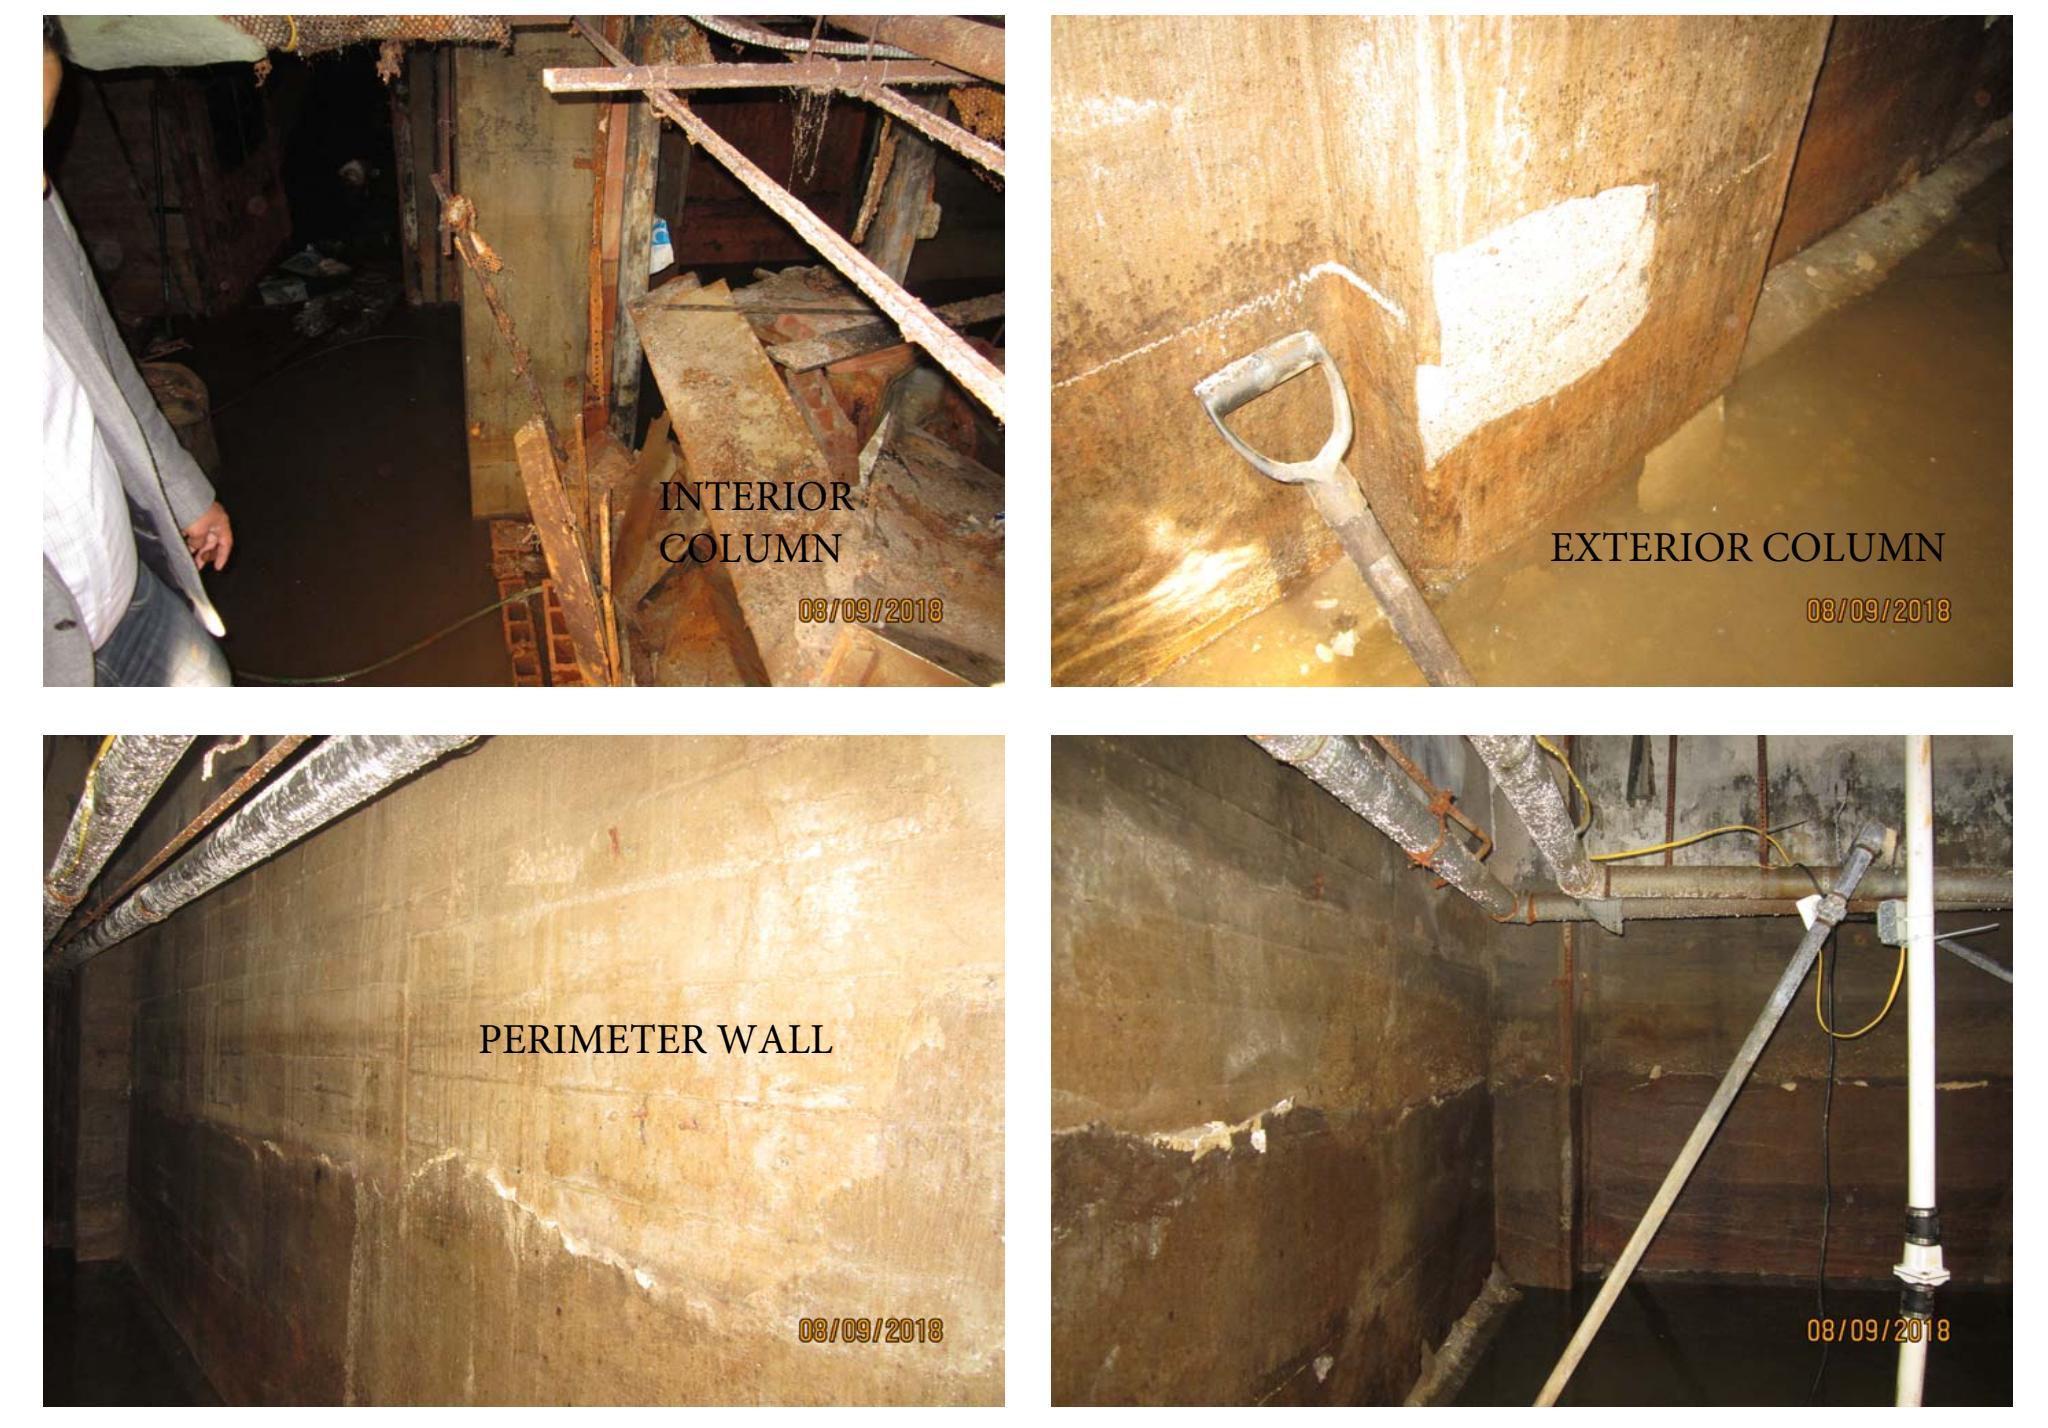
A.5 Basement: The building has a full basement with perimeter concrete walls and exterior steel columns embedded in concrete. The walls were in good condition with no obvious signs of caveins, spalling, exposed corroded steel, and cracking. The basement floor was concrete slab-on grade and in walkable condition. The basement ceiling (underside of 1st floor) clay tiles and concrete encased steel beams were visible and in good condition. The interior columns were observed at many locations and were covered with concrete encasement. In general, among all the debris, we could not find any signs of structural distress, loose concrete, corroded steel, sagging floors, etc. The observed conditions in basement are photographically shown in Appendix B. pages 9 and 10.

BASEMENT PERIMETER WALLS AND CONCRETE ENCASED INTERIOR COLUMNS . NOTE GOOD CONDITION OF WALLS AND COLUMNS. Pag

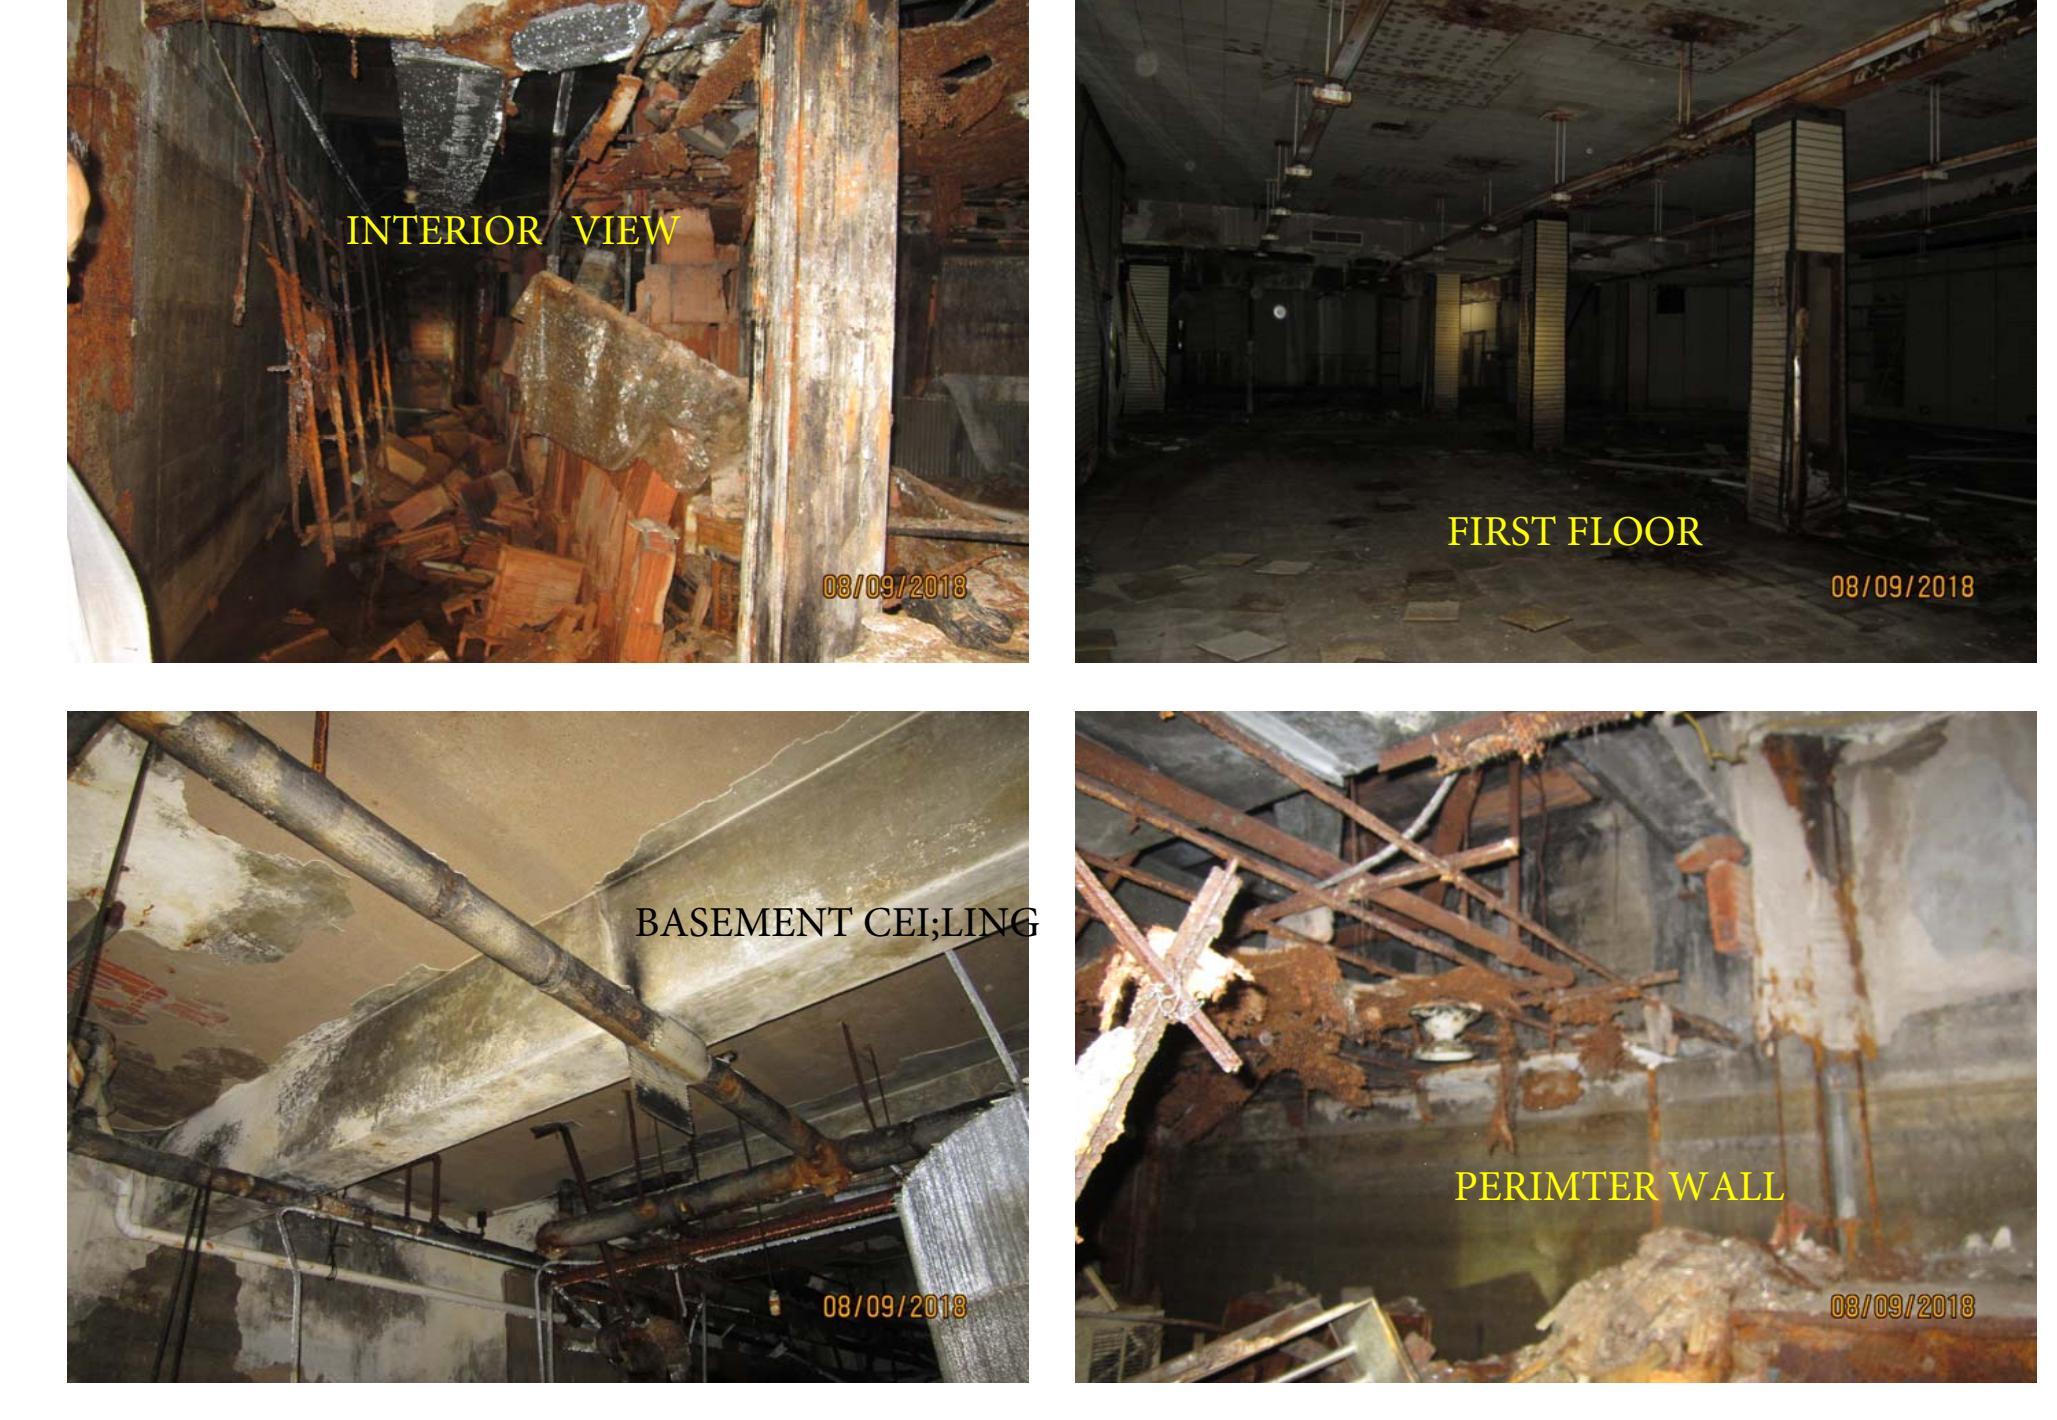
BASEMENT INTERIOR : Note no signs of structural damage or distress such as fallen concrete . Page 10
