STRUCTURAL ASSESSMENT REPORT

WASHINGTON PARK NATIONAL BANK

6300 South Cottage Grove Ave. Chicago, Illinois 60637

RE: Structural Assessment Report for Washington Park National Bank Building 6300 S. Cottage Grove Chicago, Illinois, 60637 Probe Project No: 2018.529

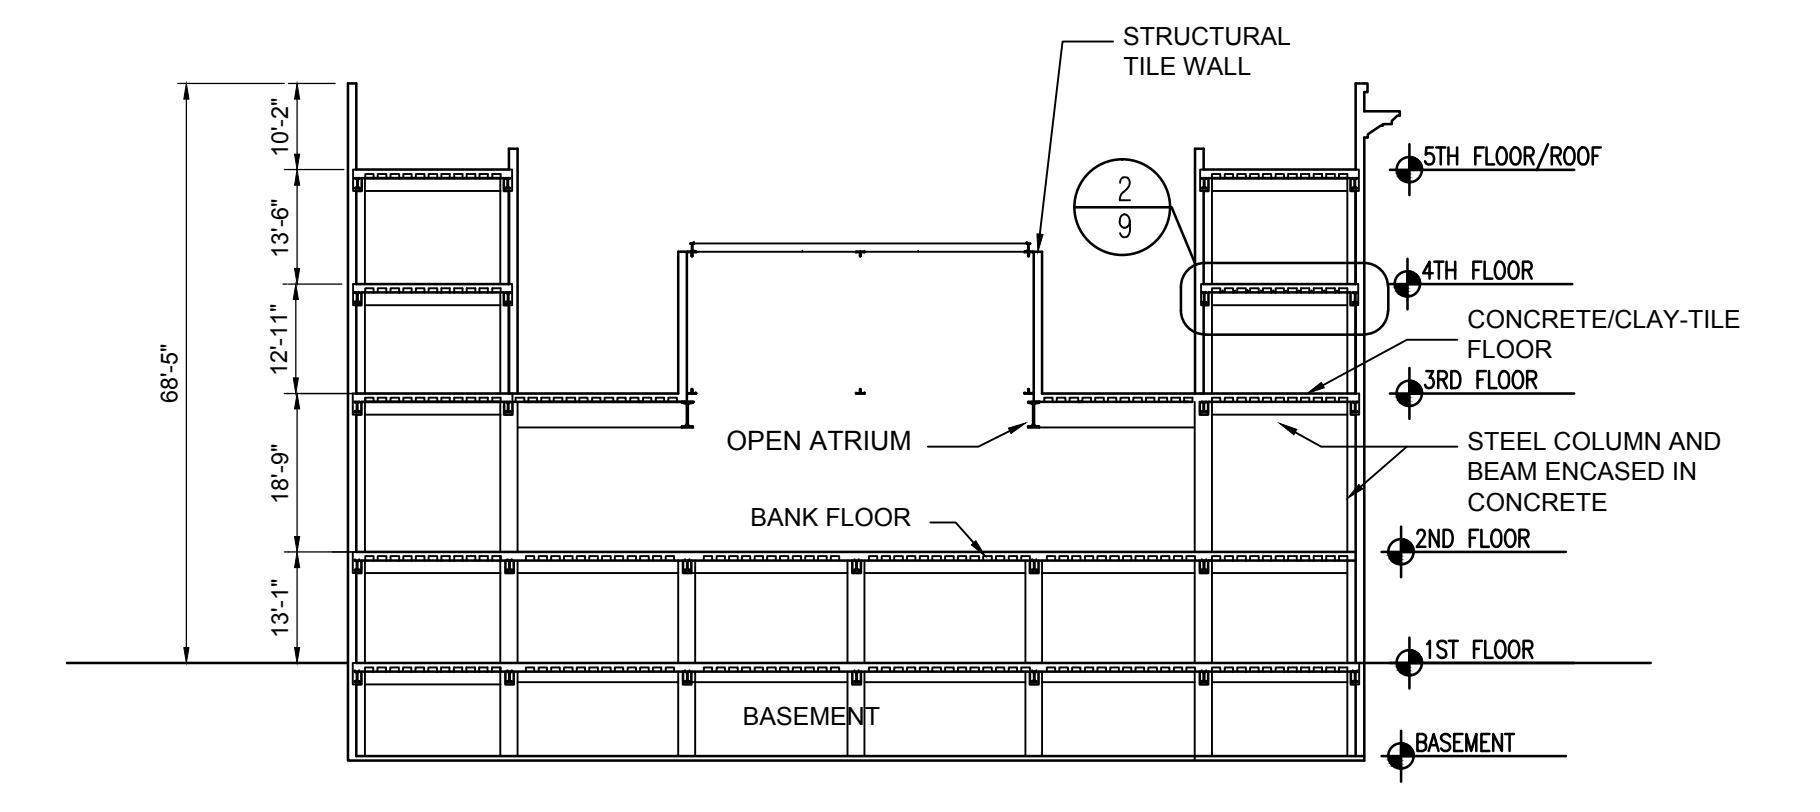
SECTION C-C CONCEPTUAL FRAMING SYSTEM WASHINGTON NATIONAL BANK BUILDING 6300 SOUTH COTTTAGE GROVE

A.2 Structural Framing: The structural framing system of the 4-story building consists of steel columns, girders, and beams encased in concrete or mortar. It is believed that exterior walls are supported by steel spandrel beams with in-fill brick masonry. The 3rd 4th, and the roof-top floors are composed of clay tiles and reinforced concrete joists. The observed construction is consistent with our experience with similar buildings built in 1920's. The Appendix A includes typical building cross sections assembled by us based upon the available information.

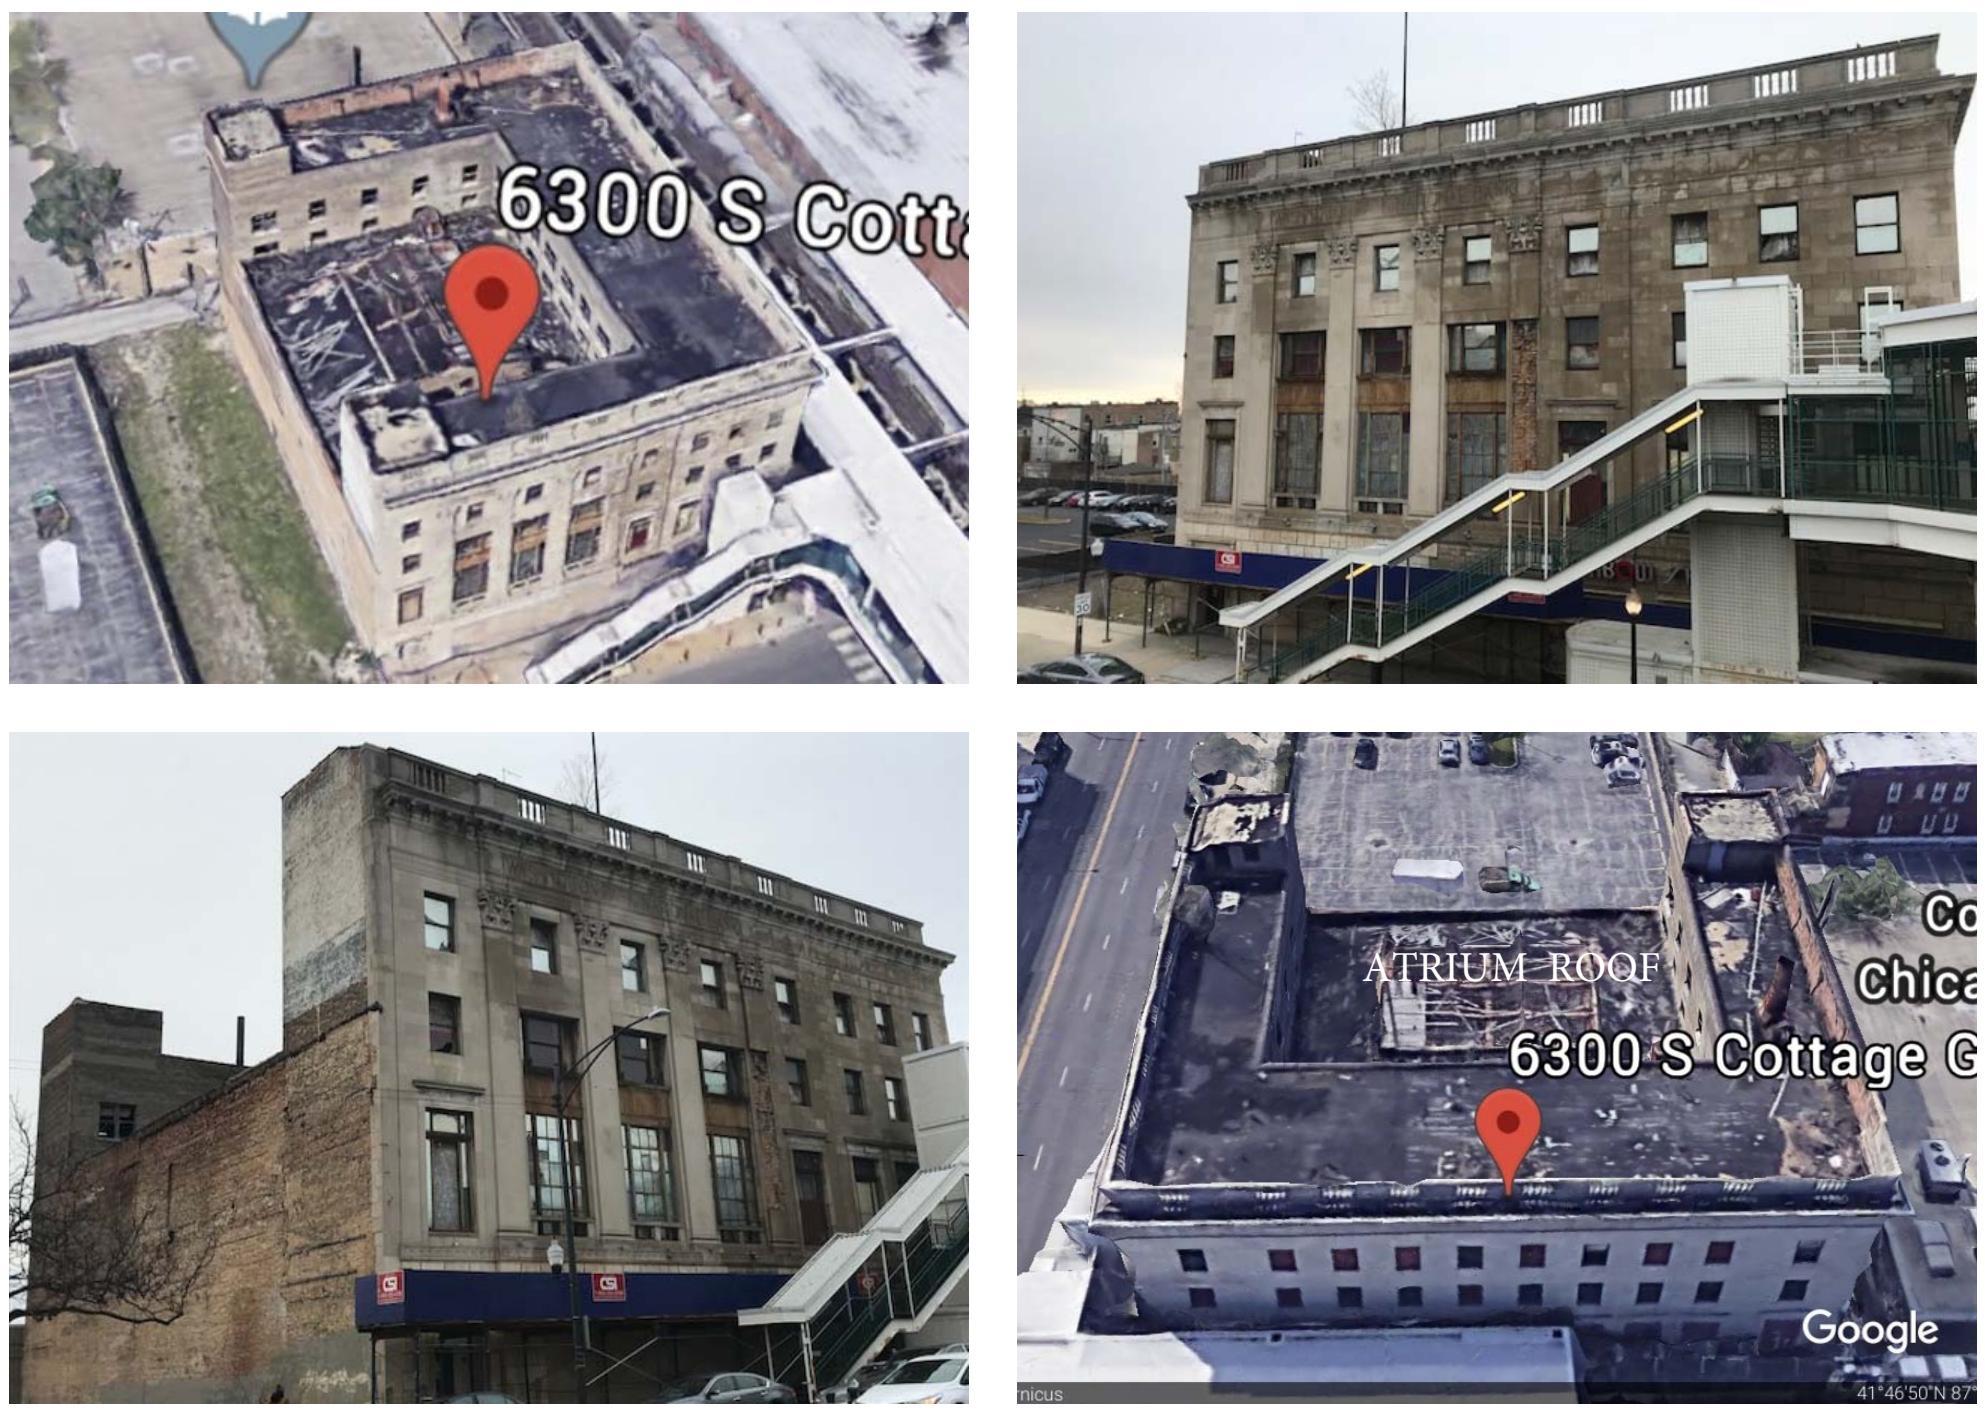
GENERAL AERIAL VIEWS OF THE BUILDING AT 6300 S. COTTAGE GROVE Page 1
